CWA INDUSTRIAL STORMWATER INSPECTION REPORT
U.S. ENVIRONMENTAL PROTECTION AGENCY, REGION 5

Purpose: Stormwater Inspection for Metal Mining Facility

Facility: Bovine Igneous Complex
Township 50N, Range 32W, Section 19
Baraga County, MI

Date of Inspection: November 1, 2011

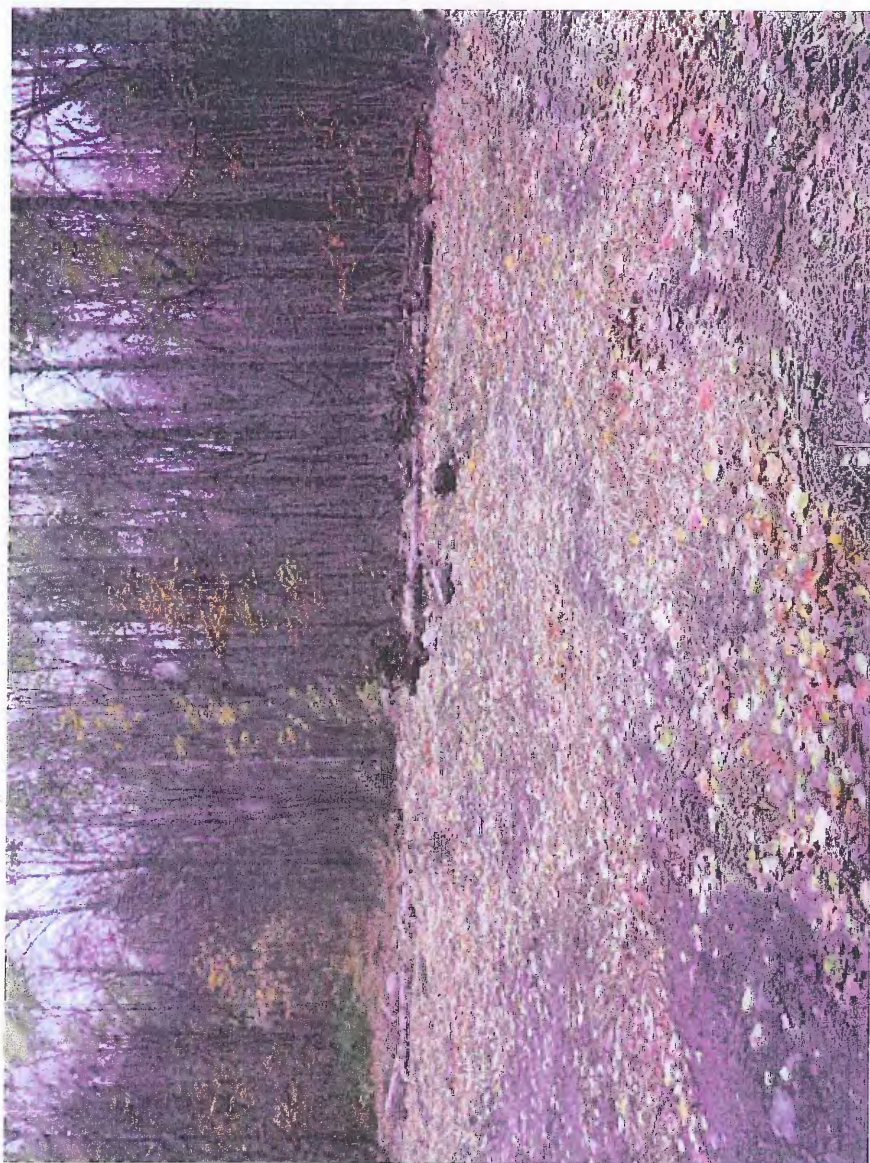
Picture 1 (IMG00005.jpg)

Pad for drill holes #11 – BIC – 056 and 11 – BIC – 057. The drill pad is estimated at 0.2 acre. There is some dirt exposed, covered with logs, boulders and hay.

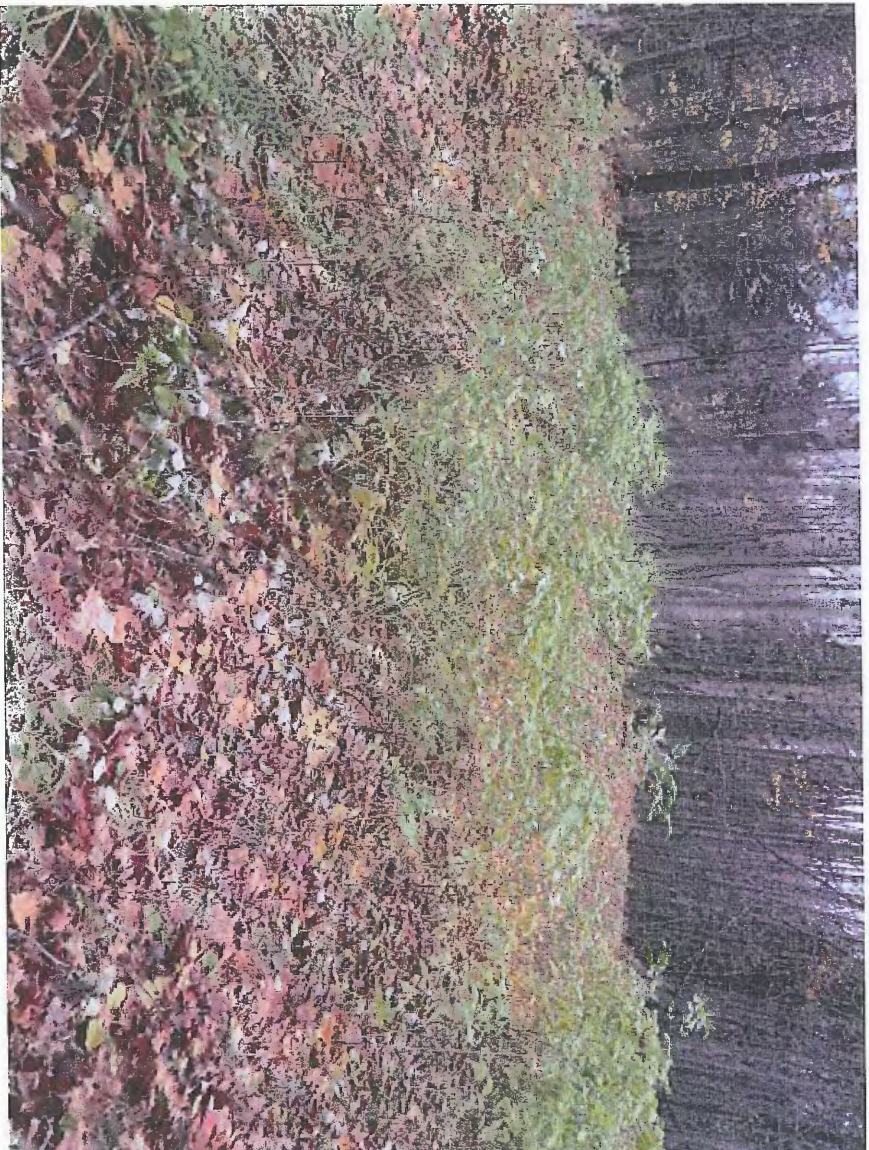
Picture 2 (IMG0006.jpg)

Pad for drill holes #06 – BIC – 001 and 06 – BIC – 002. The drill pad is estimated at 600 square feet.

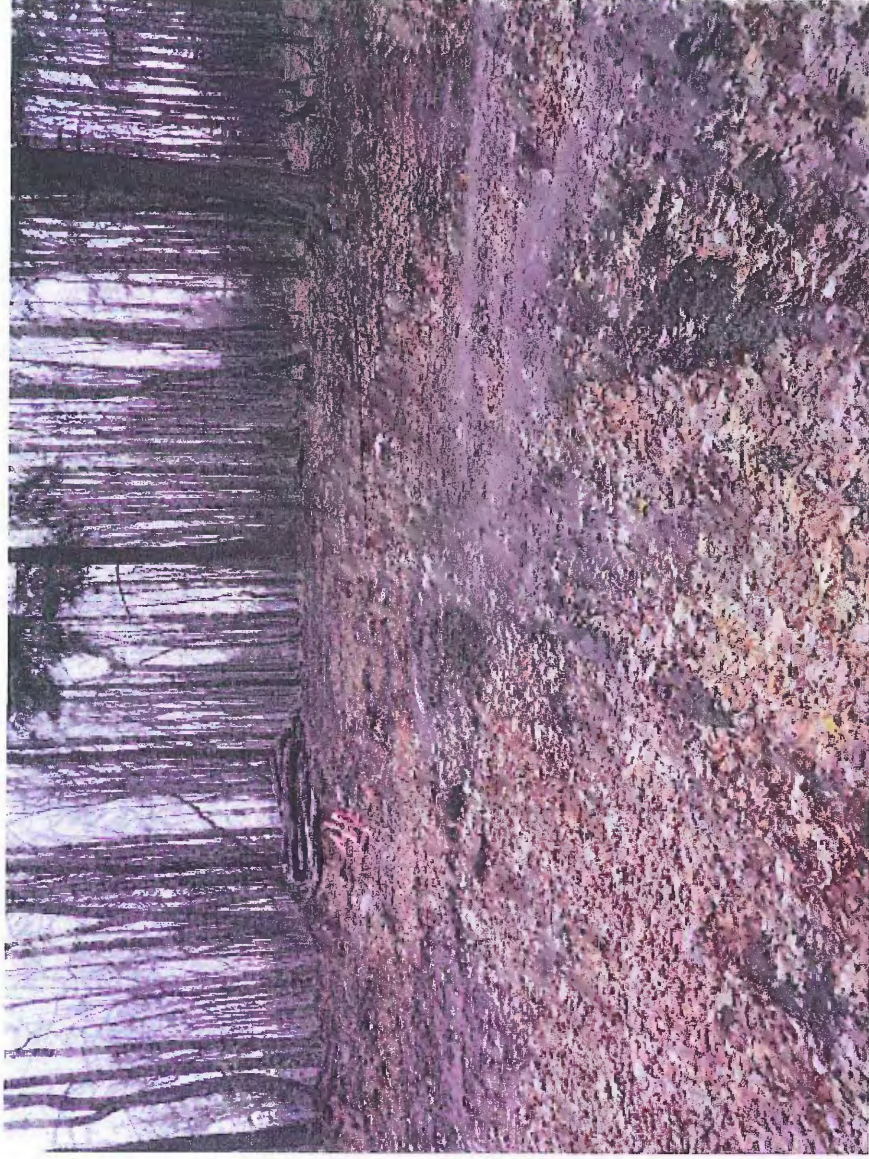
Picture 3 (IMGP0007.jpg)

Drill pad for holes #11 – BIC – 051 through 11 – BIC – 055. The drill pad is estimated at 0.2 acre. It is a leafy logging deck, a cleared area exposing dirt and tire tracks

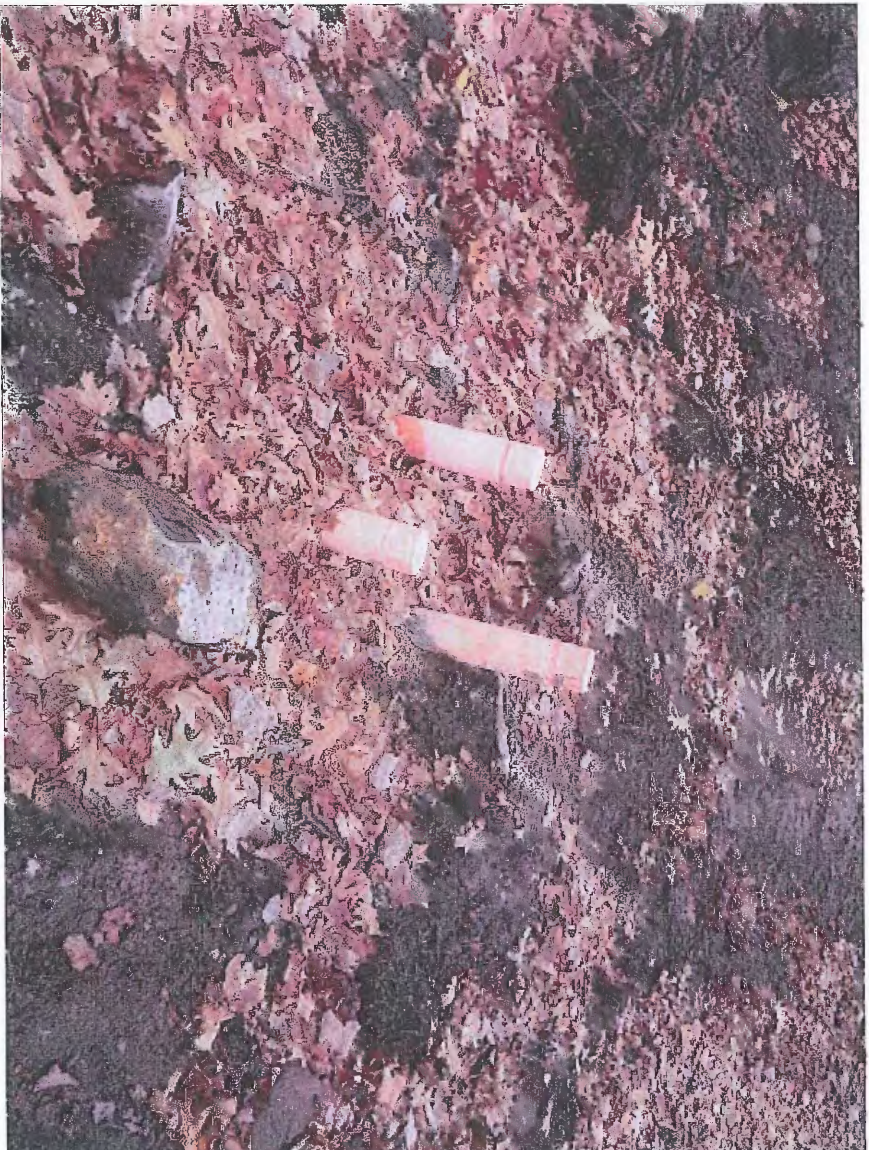
Picture 4 (IMG0008.jpg)

Drill pad for holes #11 – BIC – 051 through 11 – BIC – 055. The drill pad is estimated at 0.2 acre. It is a leafy logging deck, a cleared area exposing dirt and tire tracks

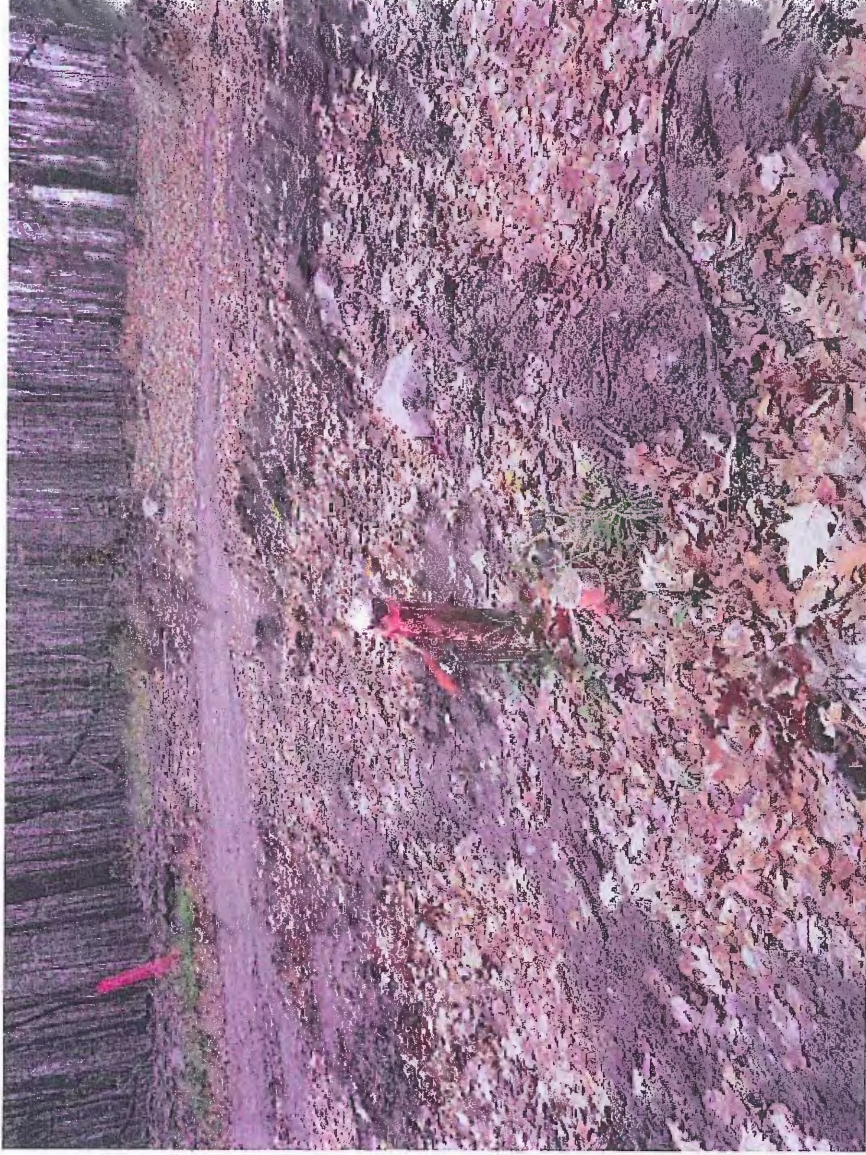
Picture 5 (IMG00009.jpg)

Drill pad for holes #11 – BIC – 051 through 11 – BIC – 055. The drill pad is estimated at 0.2 acre. It is a leafy logging deck, a cleared area exposing dirt and tire tracks

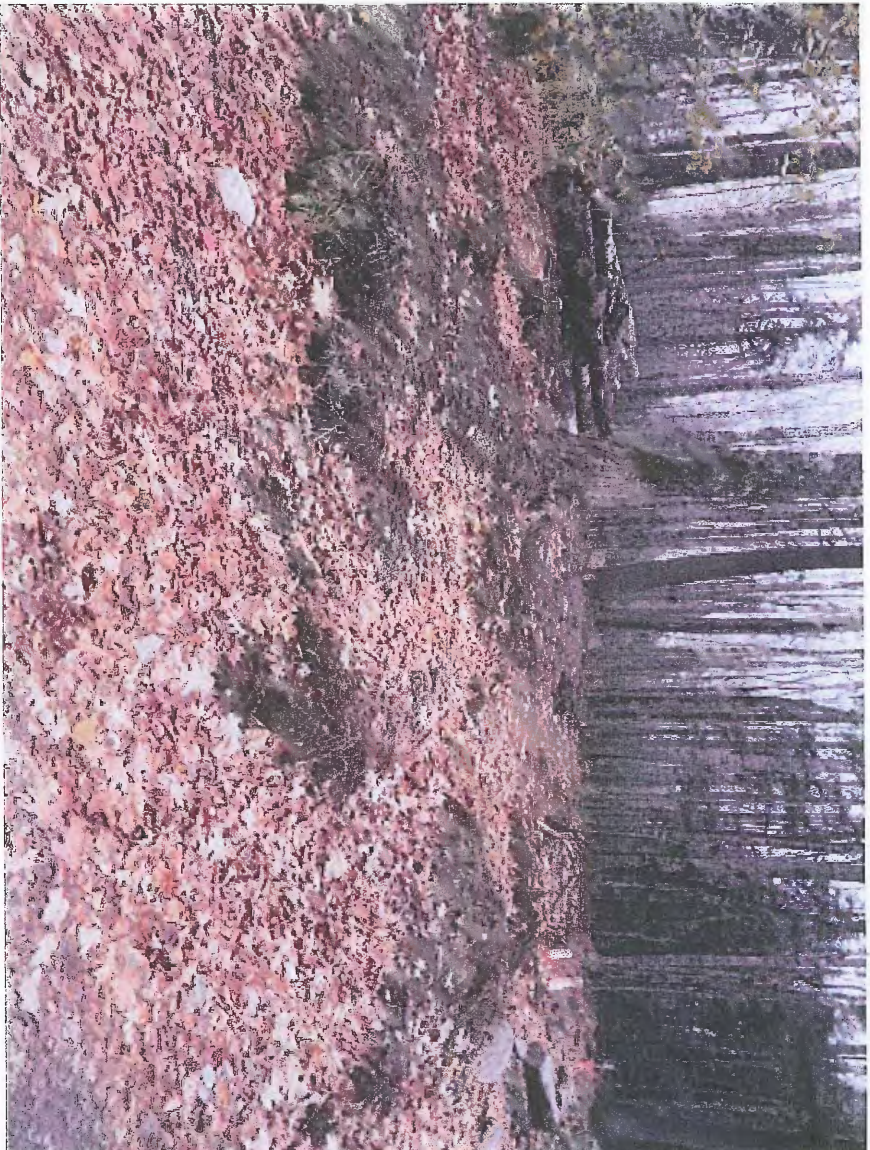
Picture 6 (IMG0010.jpg)

Drill pad for holes #11 – BIC – 051 through 11 – BIC – 055. The drill pad is estimated at 0.2 acre. It is a leafy logging deck, a cleared area exposing dirt and tire tracks.

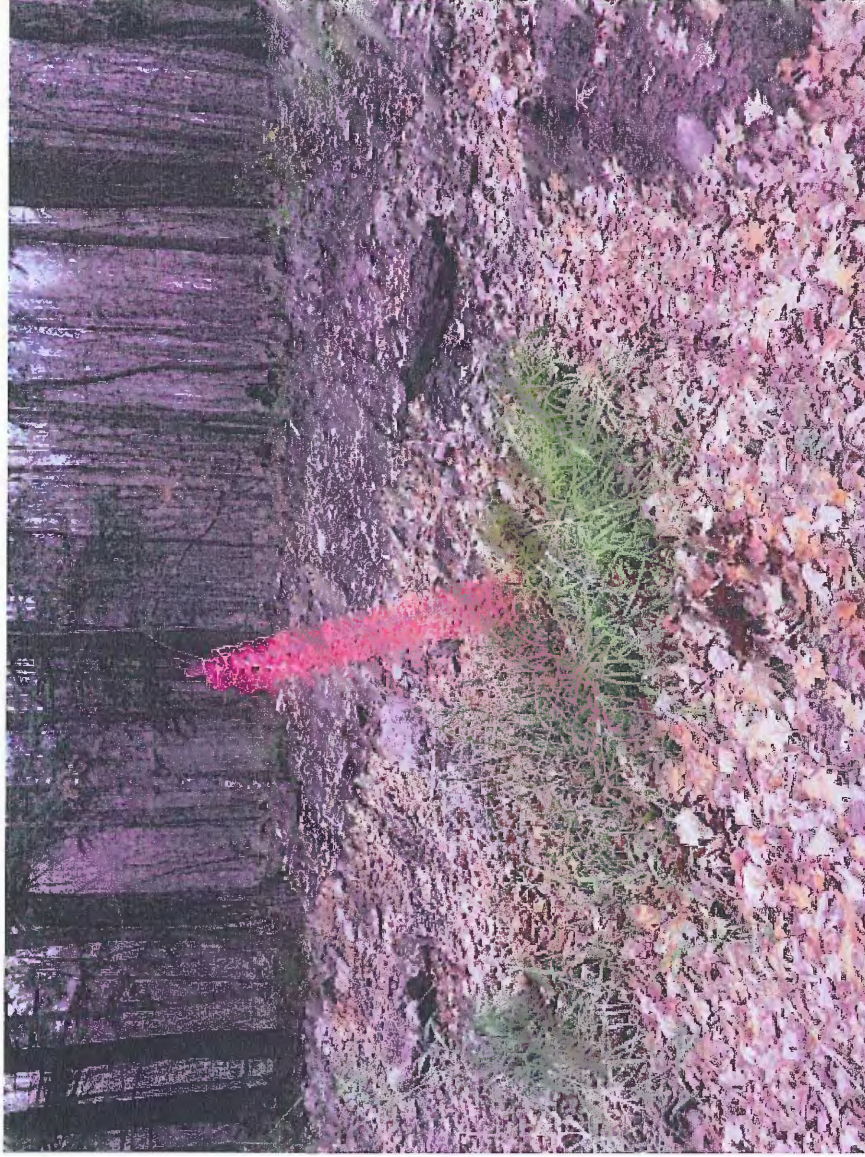
Picture 7 (IMG0011.jpg)

Drill pad for holes #11 – BIC – 051 through 11 – BIC – 055. The drill pad is estimated at 0.2 acre. It is a leafy logging deck, a cleared area exposing dirt and tire tracks

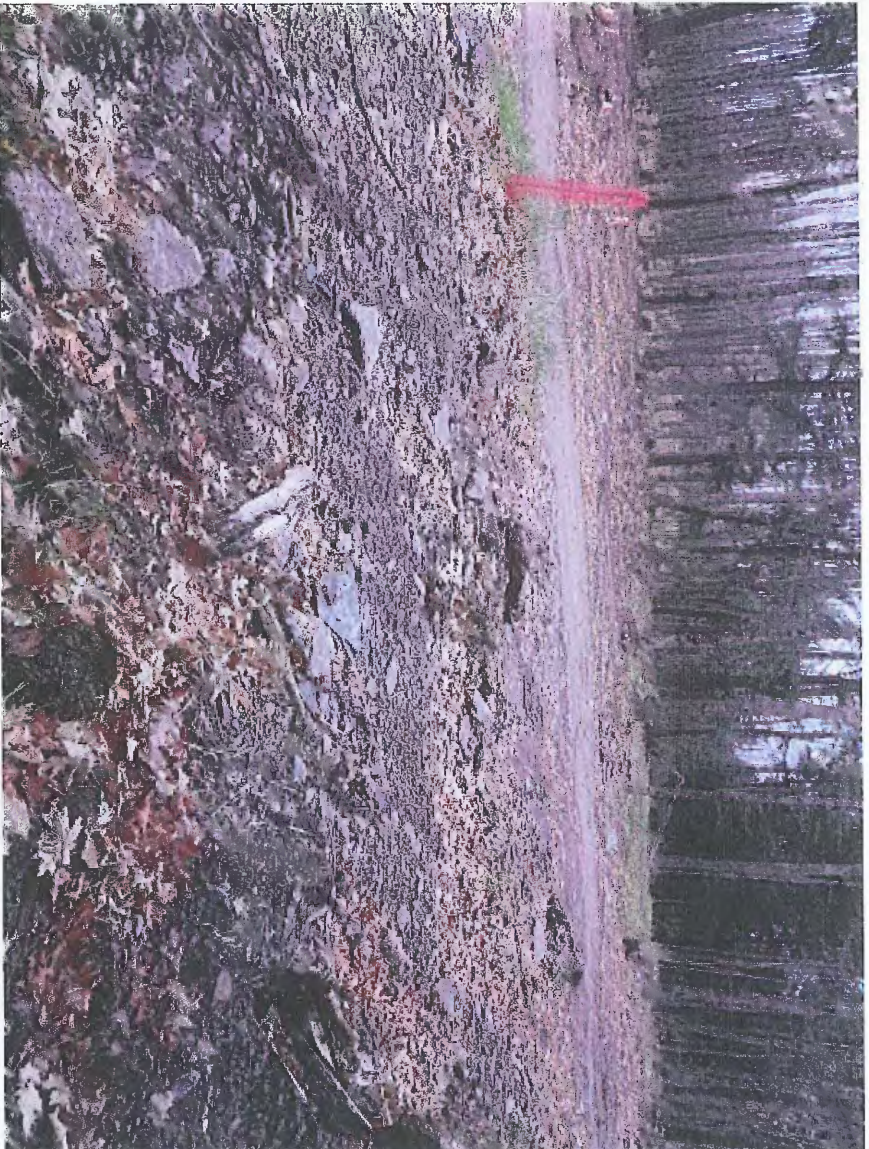
Picture 8 (IMG0012.jpg)

Drill pad for holes #11 – BIC – 051 through 11 – BIC – 055. The drill pad is estimated at 0.2 acre. It is a leafy logging deck, a cleared area with exposed dirt and tire tracks.

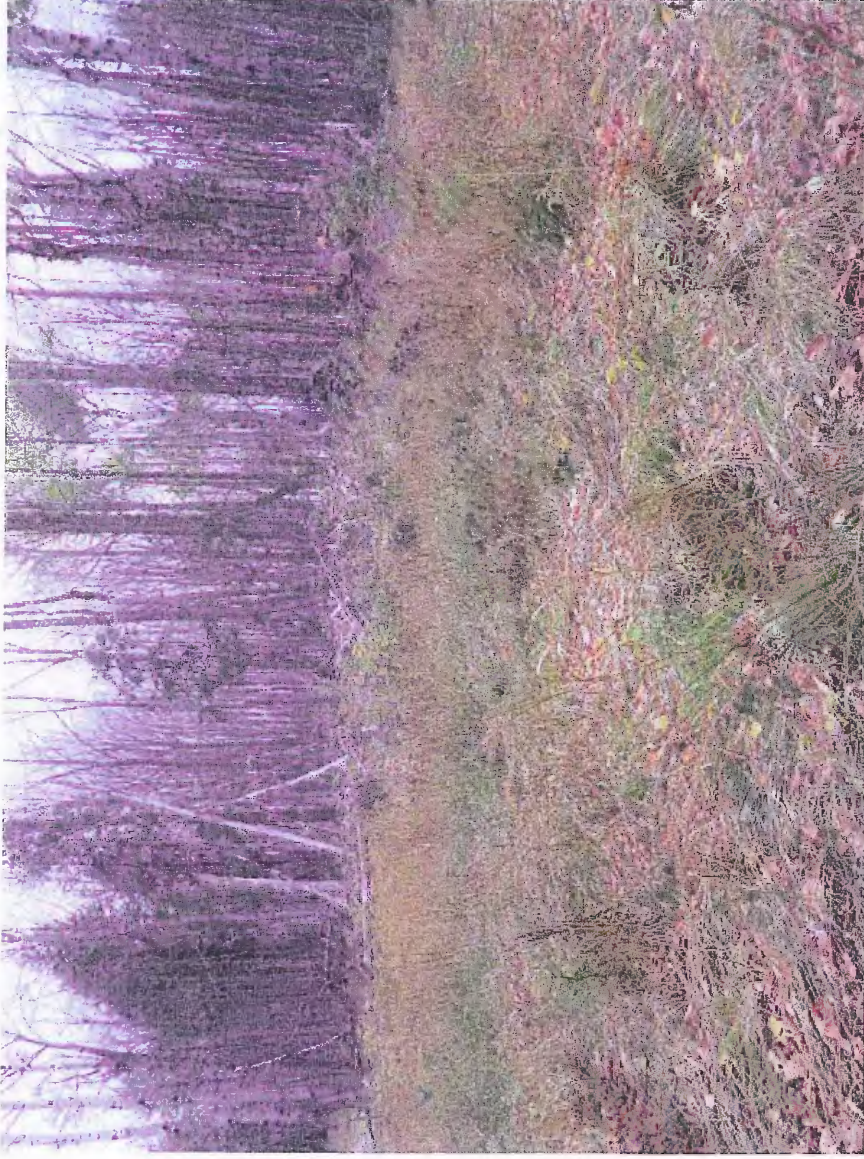
Picture 9 (IMGP0013.jpg)

Unidentified drill site. It is a vegetated logging deck, estimated at 0.2 acre.

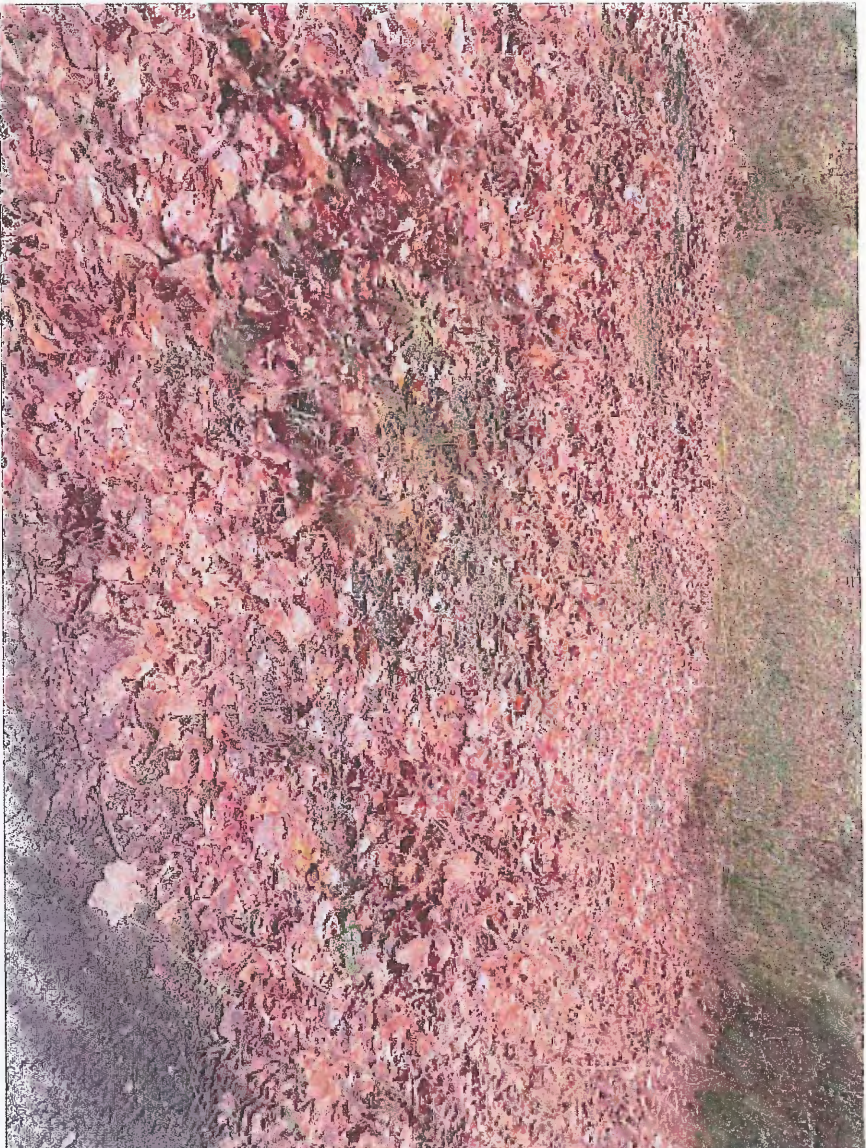
Picture 10 (IMG0014.jpg)

Three holes on unidentified leafy, gravelly pad. The pad is estimated at 600 square feet.

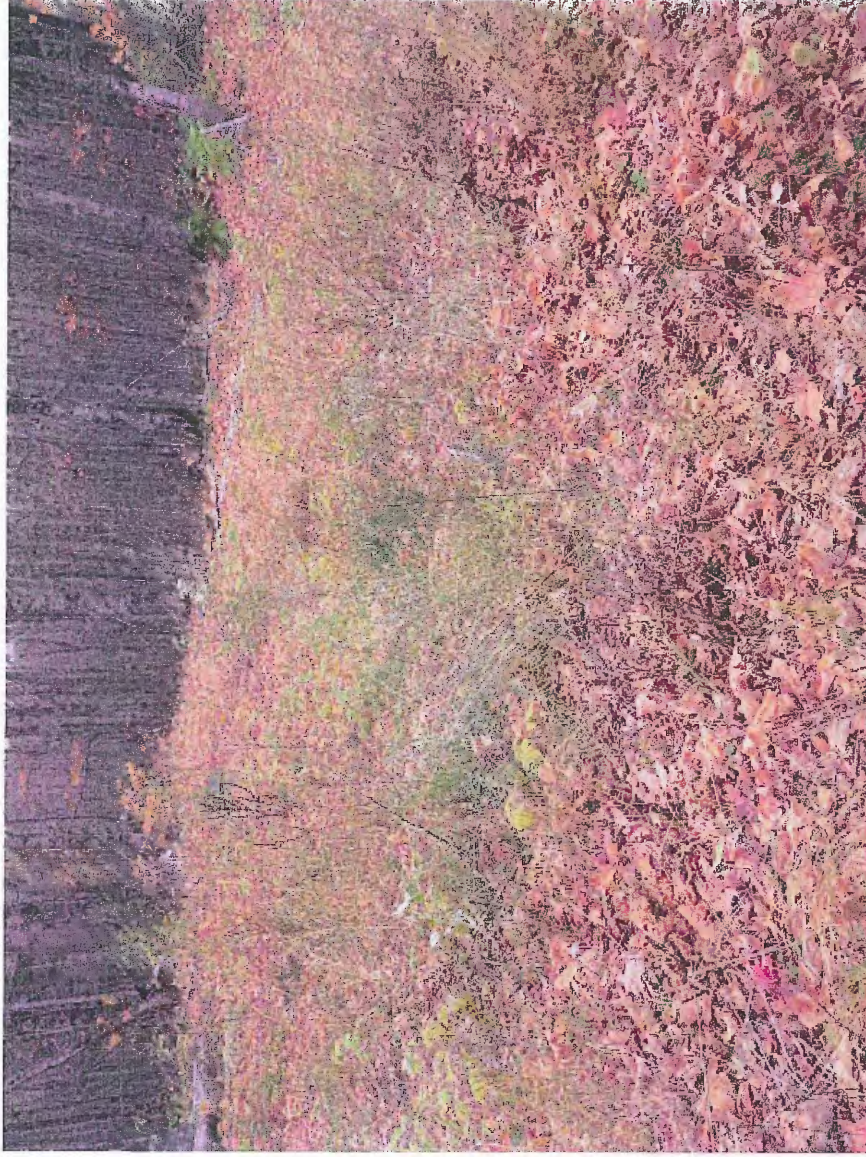
Picture 11 (IMGP0015.jpg)

Unidentified leafy and vegetated drill pad

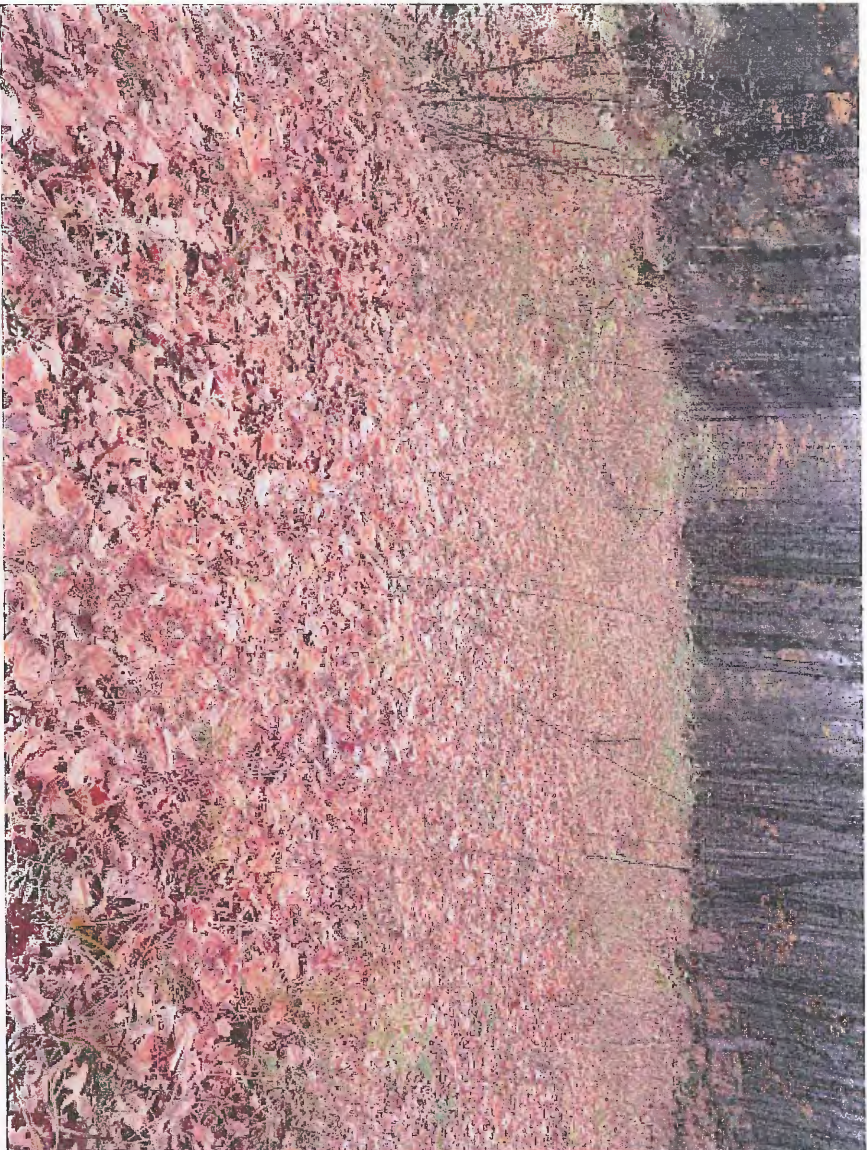
Picture 12 (IMG0016.jpg)

Unidentified leafy and vegetated drill pad

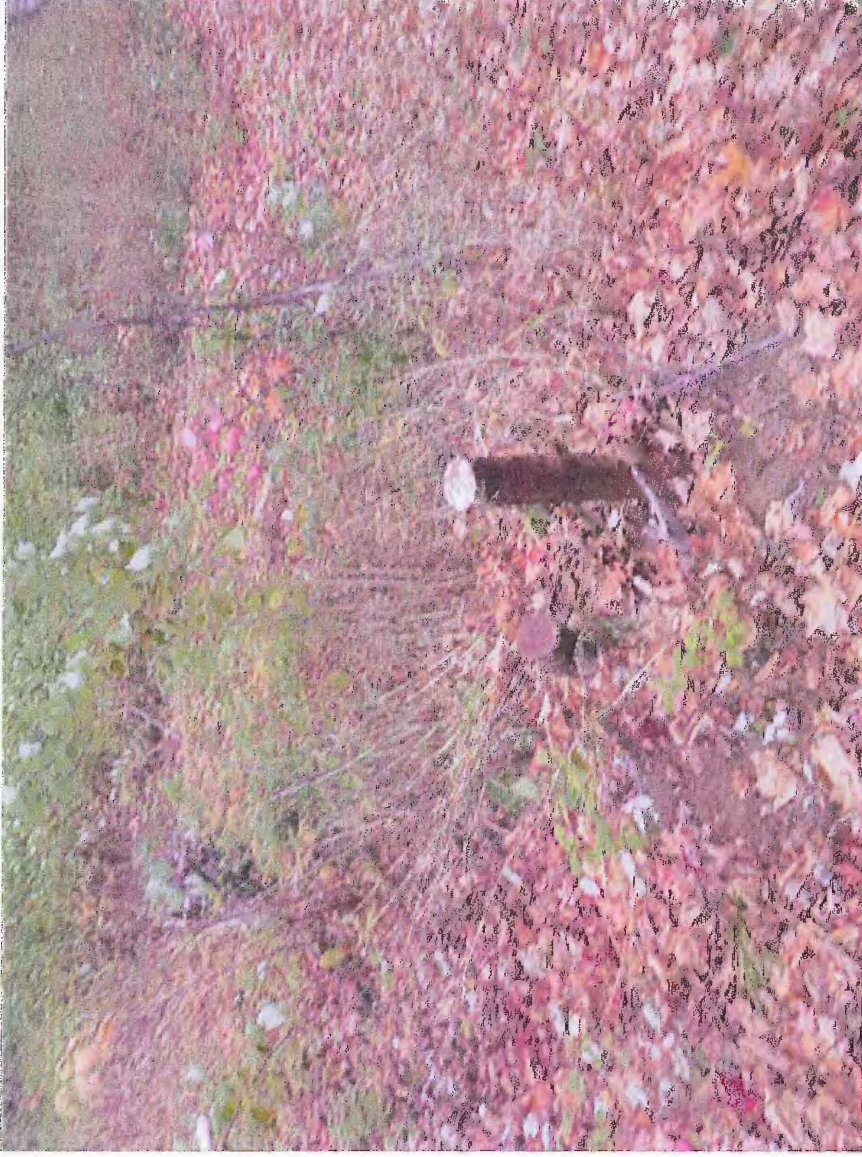
Picture 13 (IMG0017.jpg)

Mr. Ware paced the length of the road connecting two drill pads (between the pads photographed as Pictures 13 and 14). Kennecott constructed this road, according to Mr. Ware. Mr. Ware estimated the length of the road to be 202 yards, and the width to be 5 yards.

Unidentified leafy vegetated drill pad, with uprooted tree stumps. The drill pad is estimated at 800 square feet.

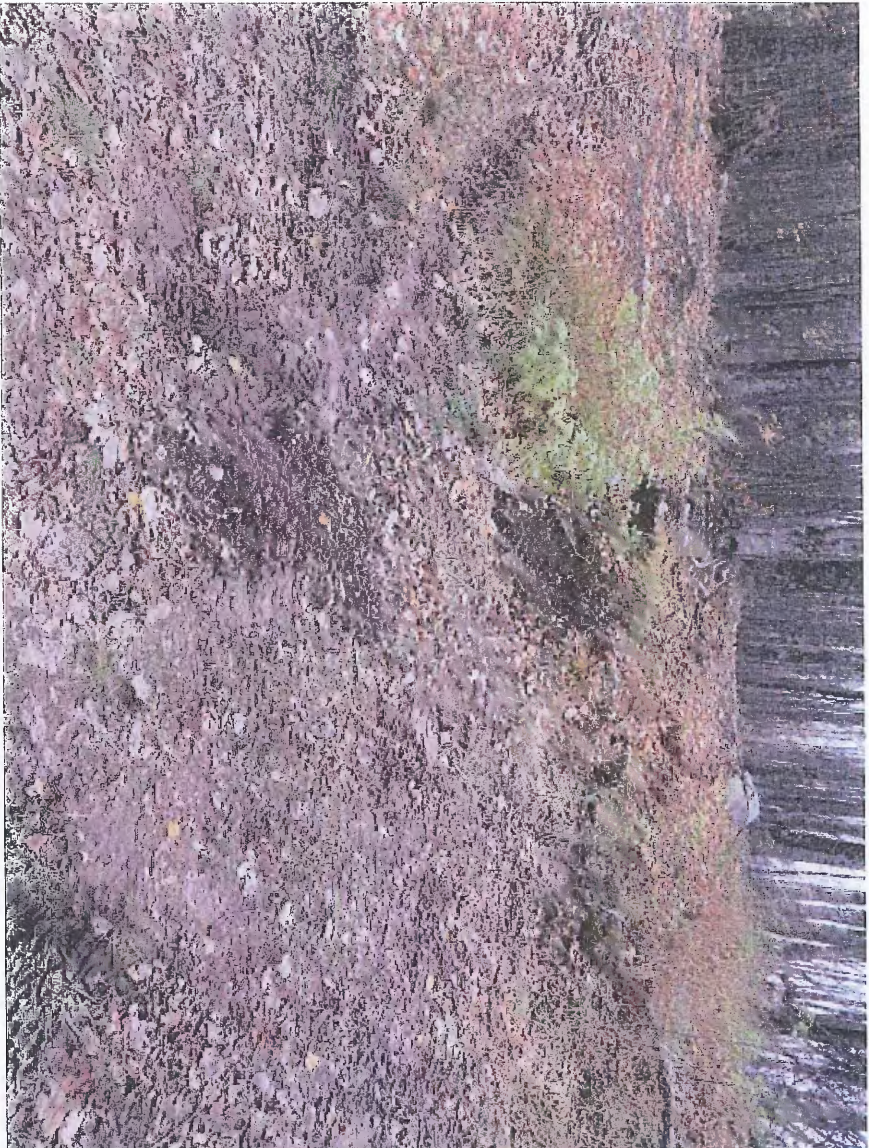
Picture 14 (IMG0018.jpg)

Muddy drill pad with tire tracks. The drill pad is estimated at 500 square feet.

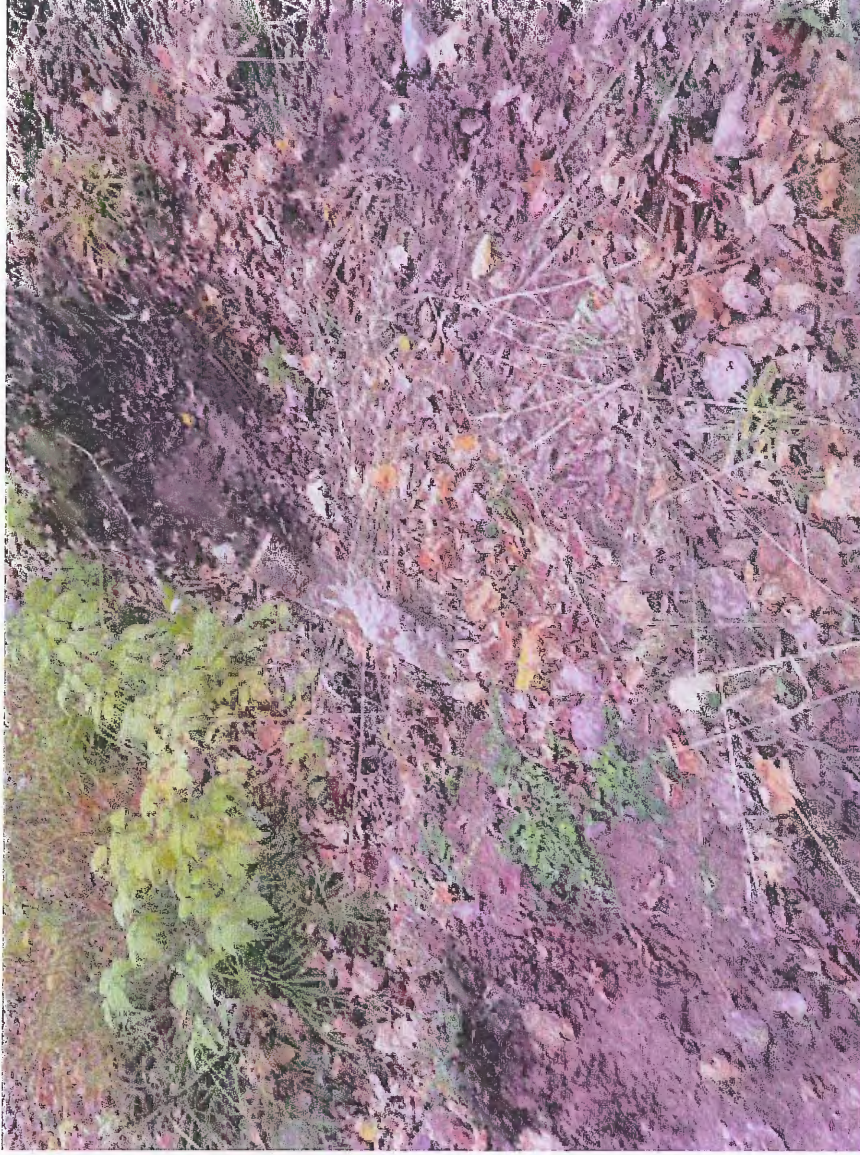
Picture 15 (IMGP0019.jpg)

Muddy drill pad with tire tracks. The drill pad is estimated at 500 square feet.

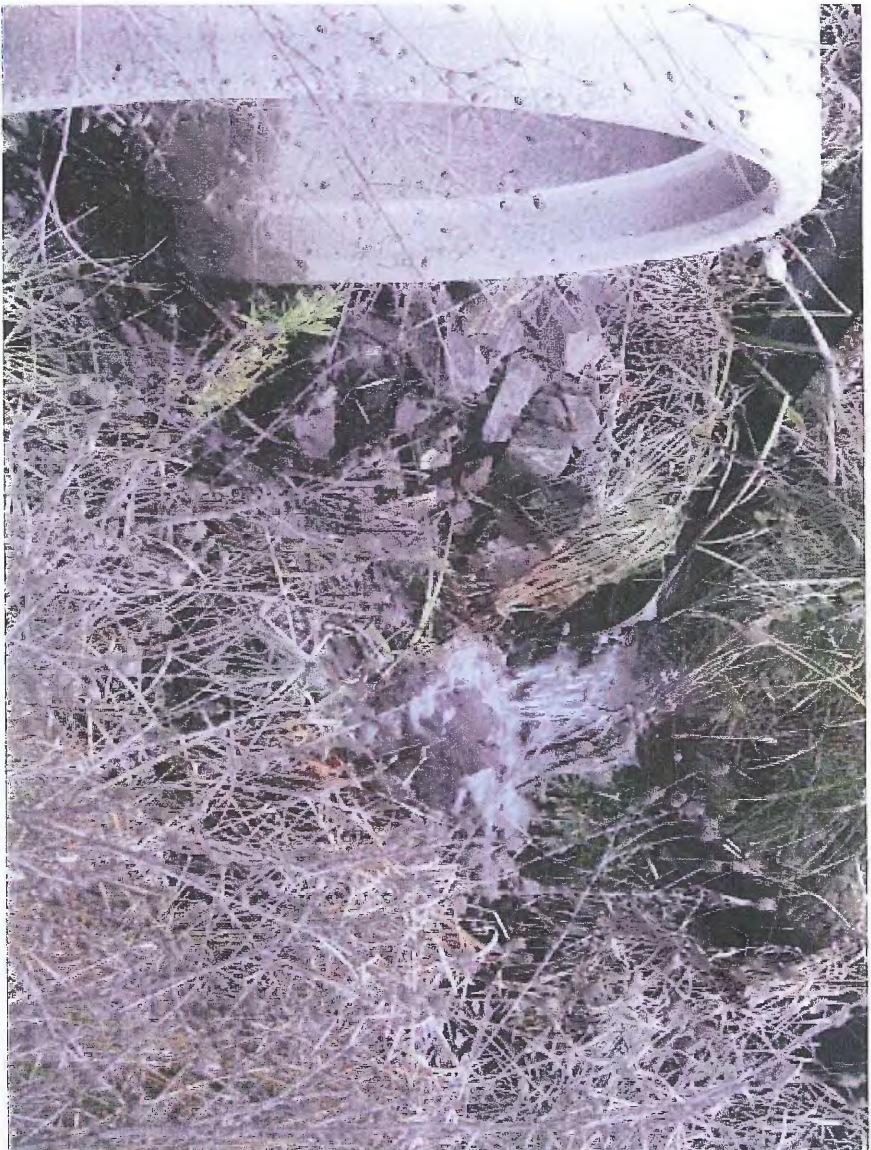
Picture 16 (IMG0020.jpg)

Mr. Ware showed me a beaver dam and wetland next to the BIC site access road (Attachment B, Pictures 16 through 19). Kennecott formerly used another road to access the site. KBIC purchased that road, and asked Kennecott to stop using it. Therefore, Kennecott chose to use the present access road by the beaver dam and wetland. Before using the road, however, Kennecott had to conduct necessary repairs. As part of those repairs, Kennecott had to construct a culvert. Kennecott applied for a permit for culvert construction from MDEQ in 2006.

Water from a beaver dam and wetland flowing over a silt fence into a culvert. The culvert is under an access road for the Bovine Igneous Complex site.

I said that I did not see evidence of erosion from the BIC site. However, I told Mr. Ware that he should consider implementing certain erosion and sediment controls at the site (e.g., seeding exposed soil to stabilize it, or using silt fencing). If the BIC site is subject to an MSGP, then Kennecott would be required to install such controls. Mr. Ware responded that Kennecott may implement such controls at the BIC site, even if EPA doesn't determine that the site is subject to an MSGP. For example, Mr. Ware said he'd consider installing rock berms at the sides of a road which crosses an intermittent stream.

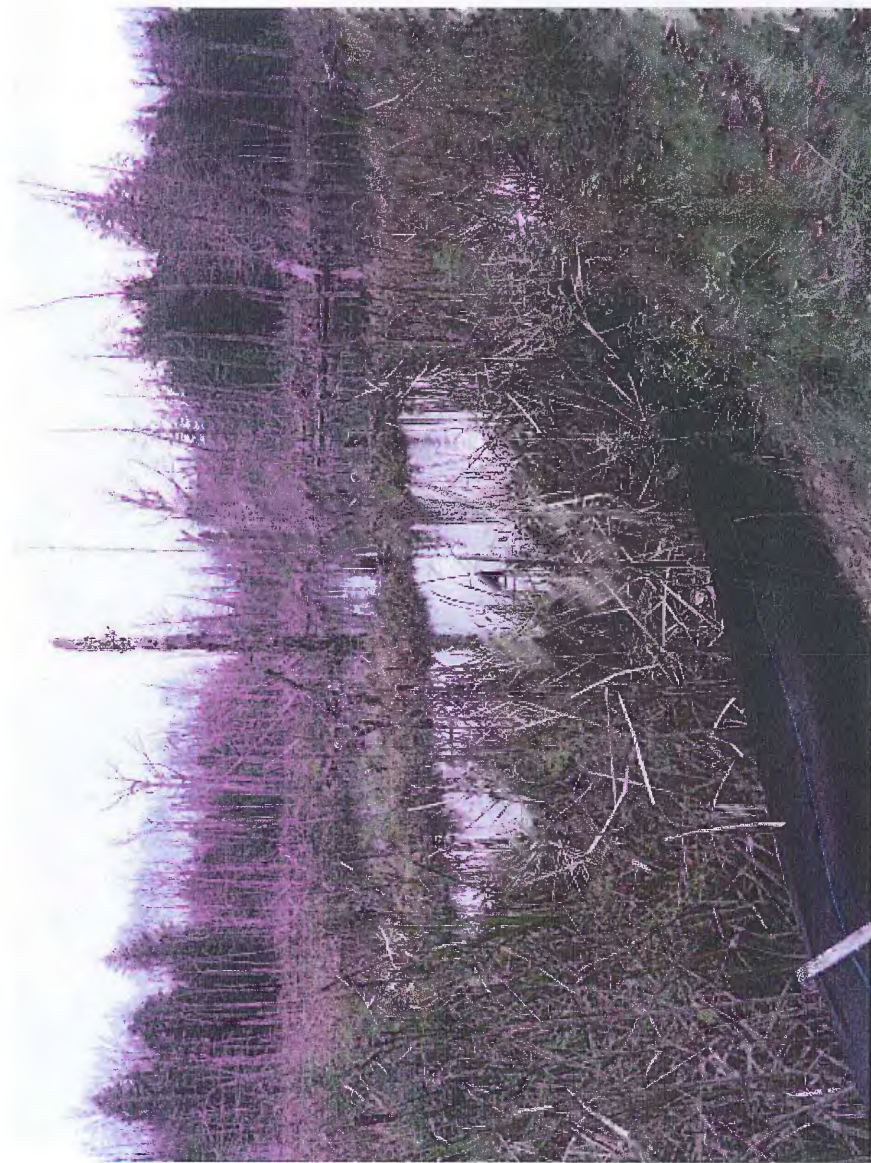
Picture 17 (IMGP0021.jpg)

Beaver dam and wetland adjacent to a Bovine Igneous Complex access road

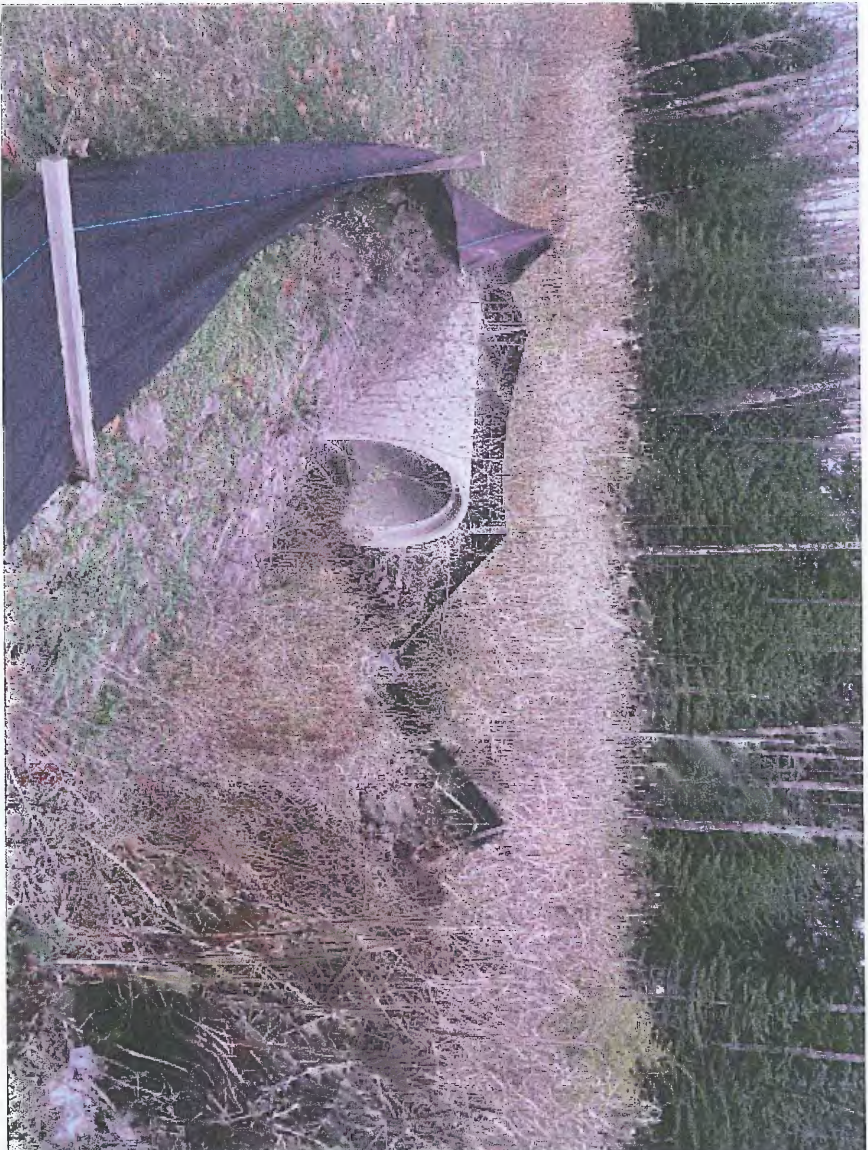
Picture 18 (IMG0022.jpg)

Culvert accepting flow from a beaver dam and wetland. A damaged silt fence crosses over the culvert. The culvert is under an access road for the Bovine Igneous Complex site.

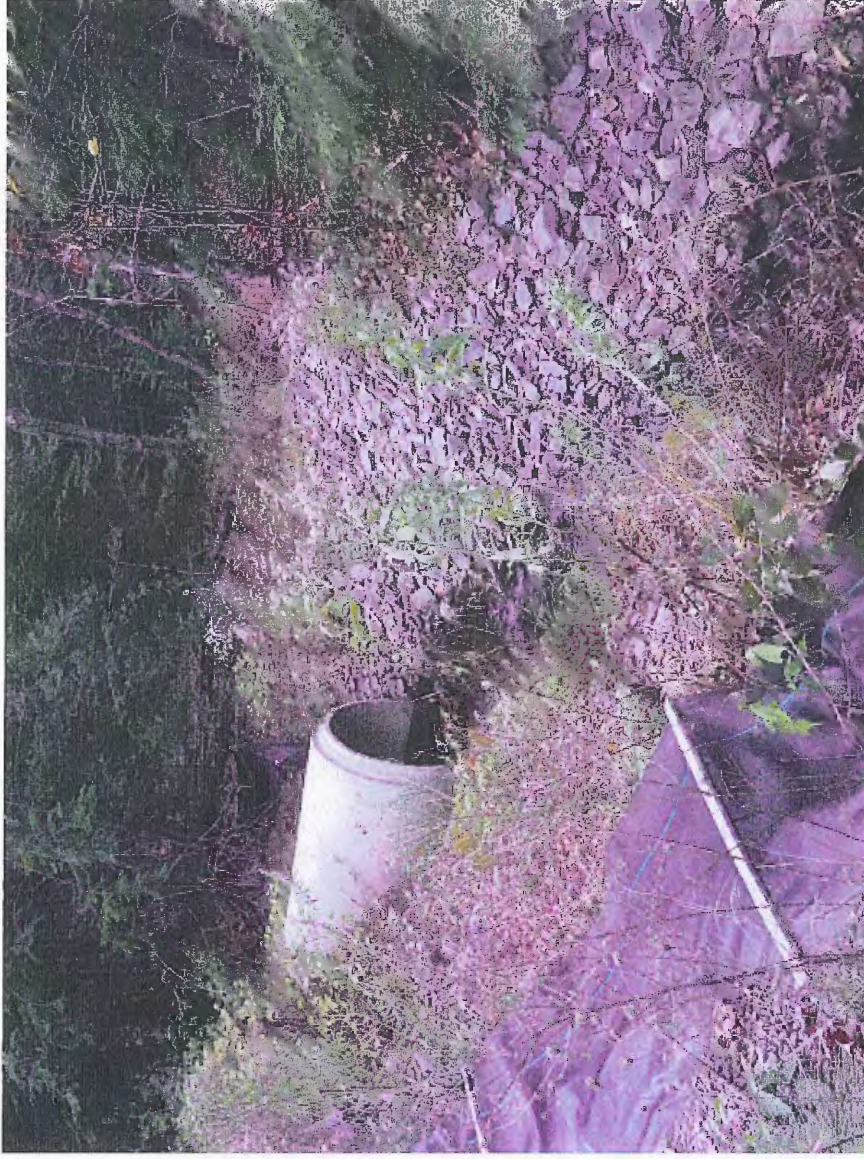
Picture 19 (IMGP0023.jpg)

Culvert discharging flow from a beaver dam and wetland. A damaged silt fence is near the culvert. The culvert is under an access road for the Bovine Igneous Complex site.

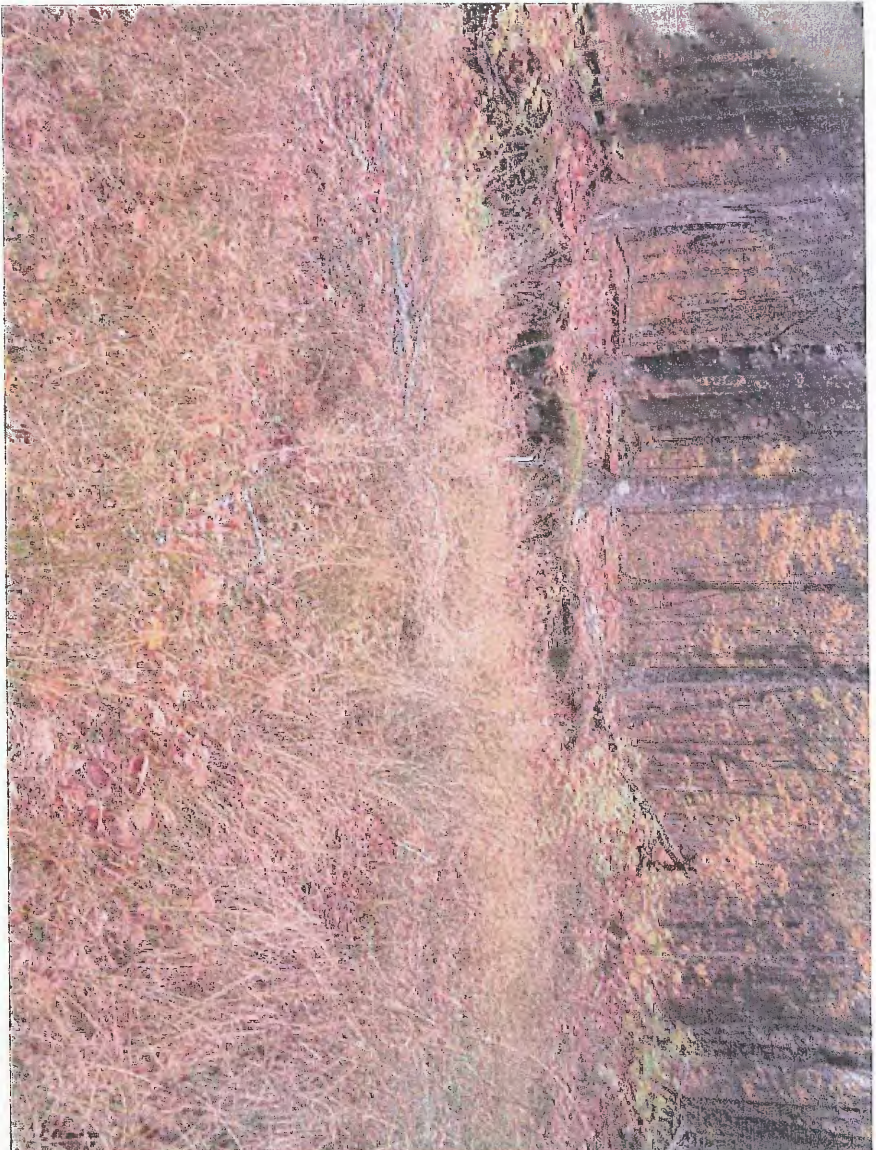
Picture 20 (IMG0024.jpg)

Unidentified, vegetated drill pad
